Re: EPA Inspection of the City of Benton Harbor public water system (PWS ID# MI0000600) in Berrien County, Michigan

Region 5 Enforcement and Compliance Assurance Division
SDWA DRINKING WATER INSPECTION REPORT

City of Benton Harbor
Berrien County, Michigan

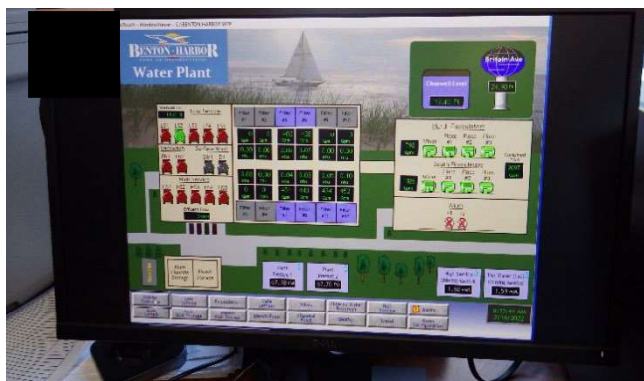
Photo 1

Description: Main Drinking Water Plant display through SCADA.

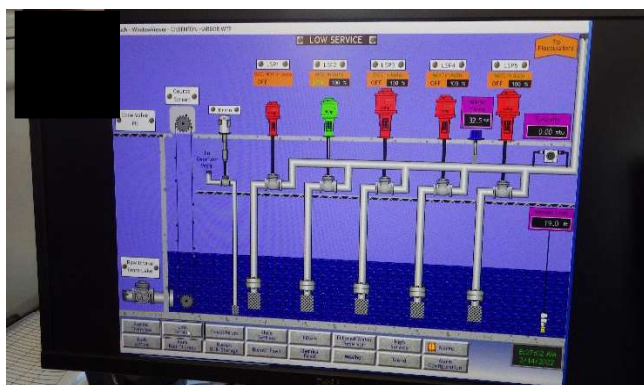
Photo 2

Description: Low service pumps display through SCADA.

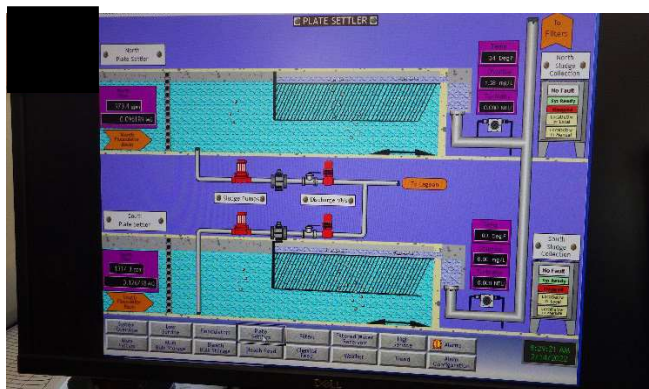
Photo 3

3. The settled water turbidimeters on the North and South Plate Settlers do not seem to be reporting to SCADA.
4. During the inspection EPA observed an increase of approximately 1 mg/L in the chlorine residual from the start of the inspection around 8:30 AM to around 10:00 AM. At the time of the inspection, it was EPA's understanding that the chlorine feed was occurring upstream of the reservoirs. Based on where chlorine is being applied to the water upstream of the reservoirs, the amount of chlorine being injected, and the location of the finished water chlorine analyzer taking measurements from the suction well it is highly unlikely that the chlorine dosing was occurring at a location upstream of the reservoirs. In follow up conversation after the inspection, it has been determined that chlorine is being injected into the suction well and not upstream of the filters as previously stated and therefore the chlorine residual spike was being observed during the day operations of the plant. The chlorine dosing directly into the suction well means that the existing continuous chlorine analyzers are not an accurate representation of the residual disinfectant levels throughout the treatment process.

Description: North and South Plate Settlers display through SCADA.

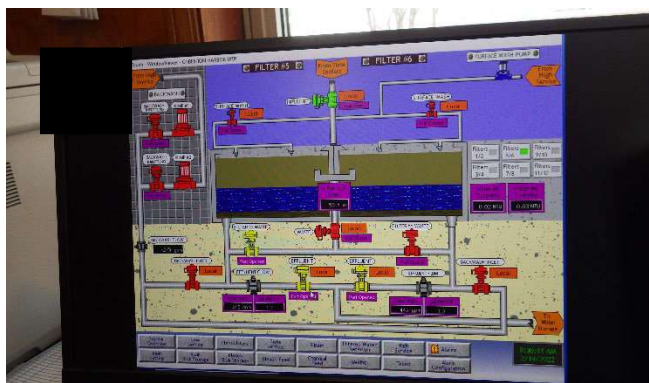
Photo 4

Description: Filters 5 and 6 display through SCADA.

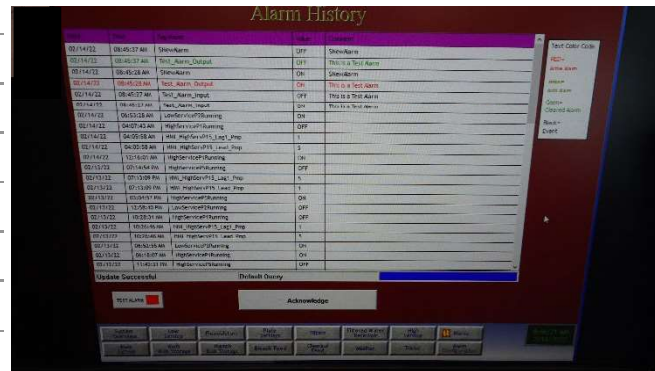
Photo 11

Description: Alarm history display through SCADA. Test alarms being triggered through SCADA.

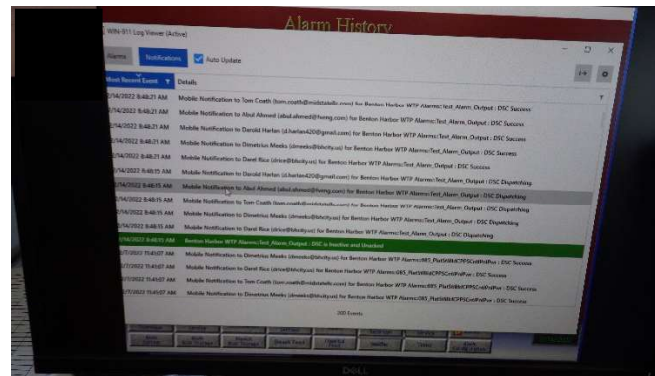
Photo 12

Description: WIN-911 notification log of the test alarms being triggered and acknowledged.

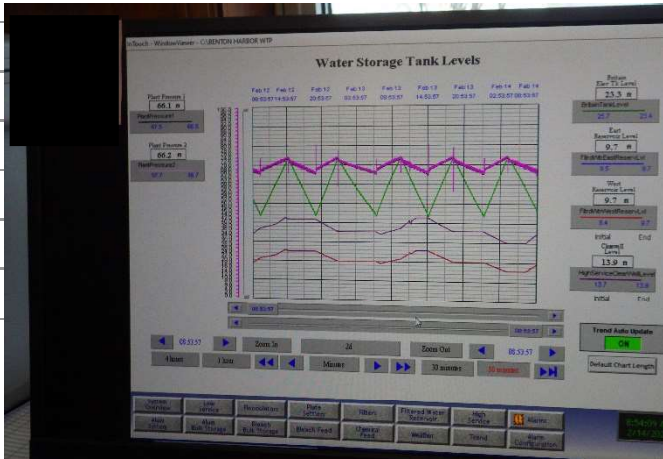
1. The SCADA alarms for Filter 12 turbidity and the Reservoir levels were disabled when observing the SCADA system at the beginning of the inspection. When EPA checked the SCADA system at the end of the inspection the System had enabled the alarms.

<p>Photo 13</p> <p>File Name: RIMG0505</p> <p>Location: Benton Harbor PWS</p> <p>02/14/2022 08:54 AM (ET)</p> <p>Photographer: Sasha Letuchy</p> <p>Camera: RICOH WG-4 GPS</p> <p>Direction of Photo: Inside</p> <p>Description: Water reservoirs displayed through SCADA.</p>

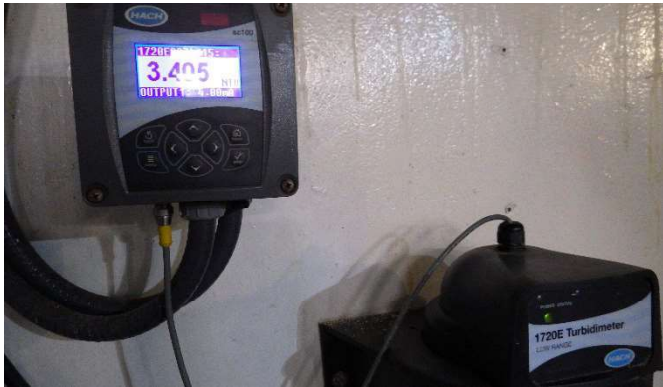
The EPA inspection team then followed Abul Ahmed to the intake of raw water into the treatment plant. Near the intake for raw water into the treatment plant is the raw water turbidimeter (See Photo 14). The raw water chlorine analyzer is not being used since the System does not inject chlorine at the intake. All numeric readings recorded while walking through the drinking water plant during the inspection can be found in Appendix C. The System stated that chlorine is injected into the raw water before it splits into the North and South Plate Settlers. The raw water turbidimeter was online and connected to SCADA.

<p>Photo 14</p> <p>File Name: RIMG0506</p> <p>Location: Benton Harbor PWS</p> <p>02/14/2022 09:00 AM (ET)</p> <p>Photographer: Sasha Letuchy</p> <p>Camera: RICOH WG-4 GPS</p> <p>Direction of Photo: Inside</p> <p>Description: Raw water turbidimeter.</p>

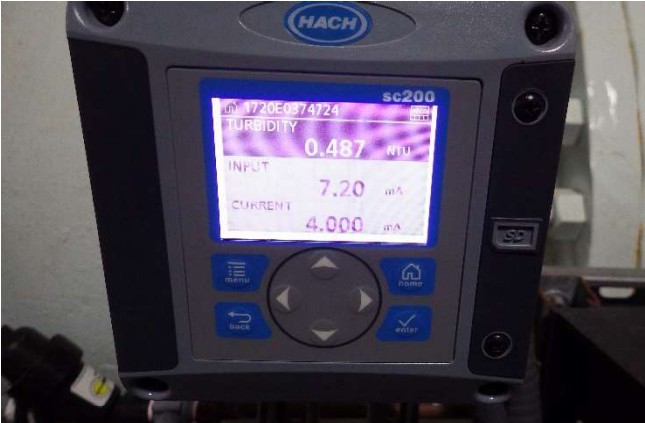
<p>Photo 19</p> <p>File Name: RIMG0511</p> <p>Location: Benton Harbor PWS</p> <p>02/14/2022 09:09 AM (ET)</p> <p>Photographer: Sasha Letuchy</p> <p>Camera: RICOH WG-4 GPS</p> <p>Direction of Photo: Inside</p> <p>Description: South Plate Settler turbidimeter.</p>

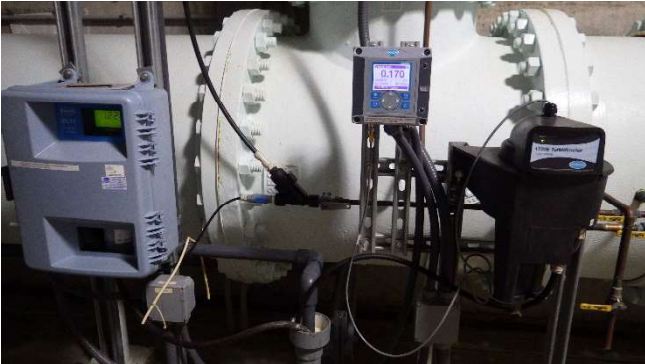
<p>Photo 20</p> <p>File Name: RIMG0512</p> <p>Location: Benton Harbor PWS</p> <p>02/14/2022 09:09 AM (ET)</p> <p>Photographer: Sasha Letuchy</p> <p>Camera: RICOH WG-4 GPS</p> <p>Direction of Photo: Inside</p> <p>Description: North Plate Settler turbidimeter and chlorine analyzer.</p>

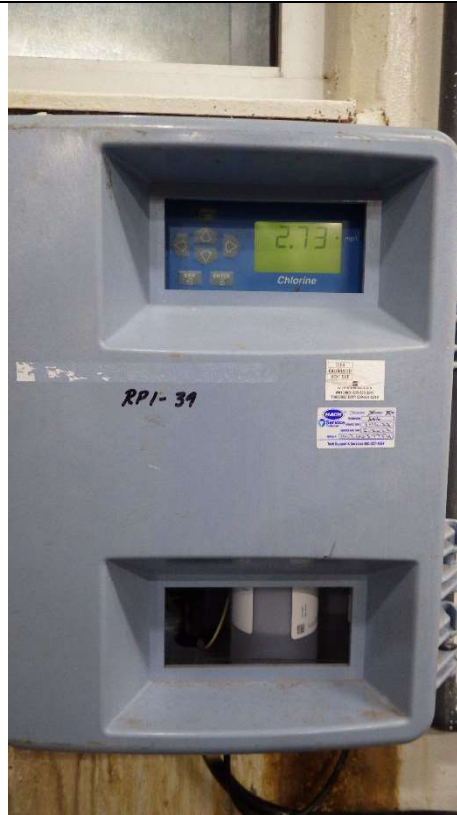
Photo 31

Description: Chlorine analyzer located near the high service pumps. This analyzer is the backup analyzer for reading chlorine residuals on finished water.

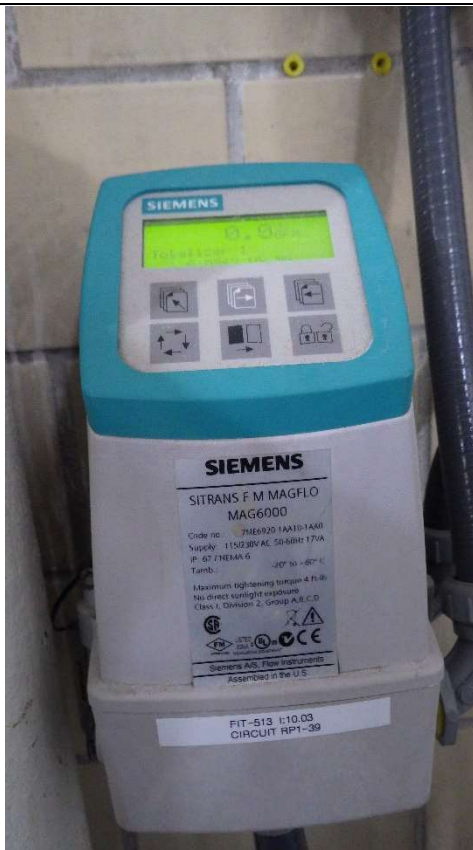
Photo 32

Description: Non-operable flow meter.

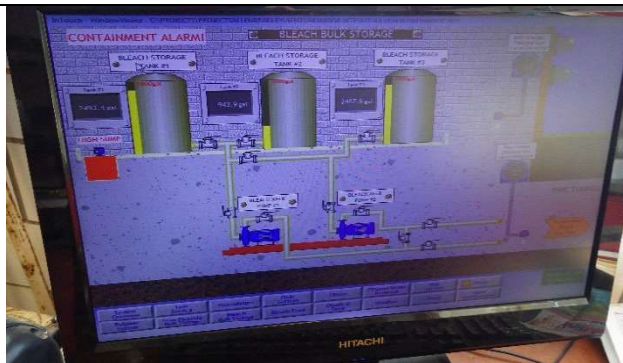
Photo 35

Description: Chlorine bulk tank SCADA display.

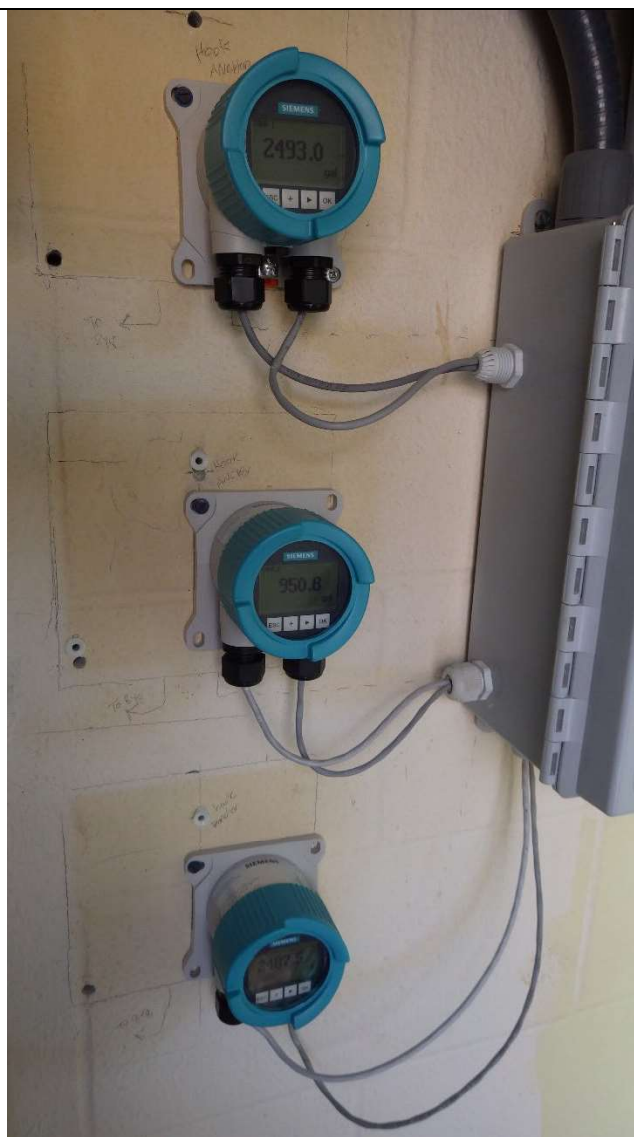
Photo 36

Description: Depth sensor for the three bulk chlorine tanks.

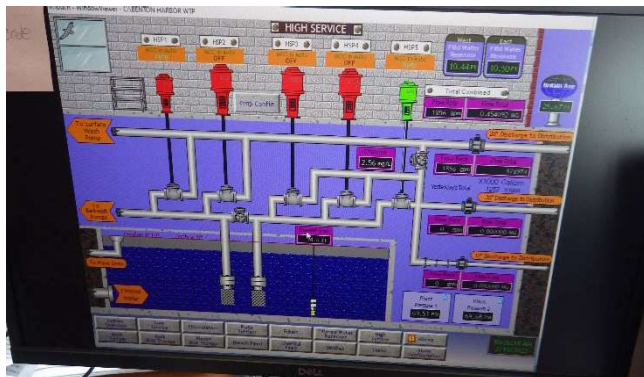
Photo 39

Description: High service pump display through SCADA.

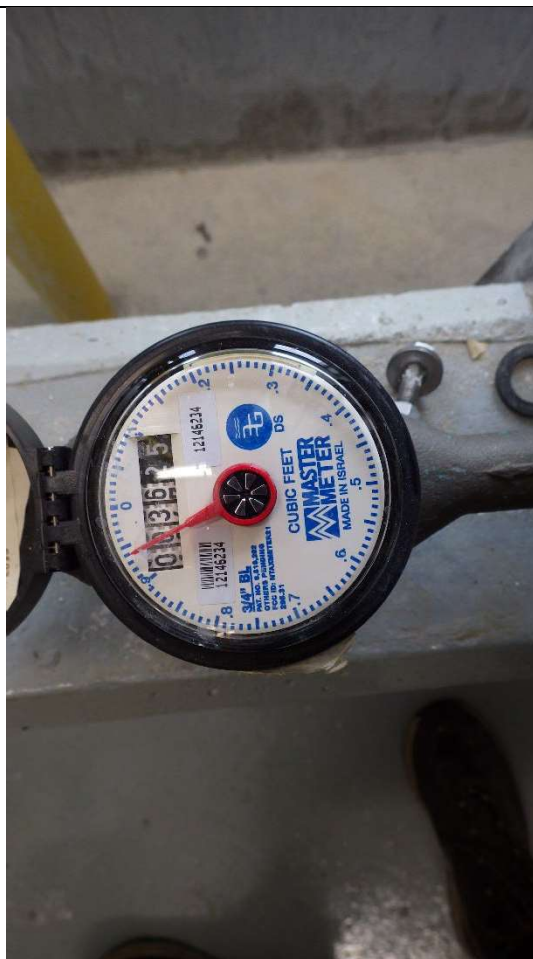
Photo 40

Description: Gallons of water pulled for fluoride saturator.

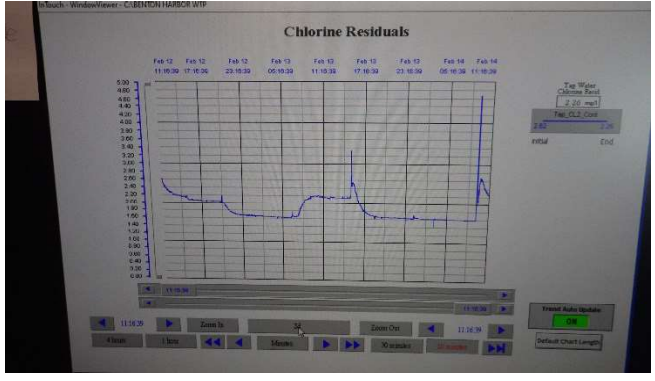
Photo 47

File Name: RIMG0539	
Location: Benton Harbor PWS	
02/14/2022 11:16 AM (ET)	
Photographer: Sasha Letuchy	
Camera: RICOH WG-4 GPS	
Direction of Photo: Inside	
Description: Historical chlorine residual readings for February 14, 2022.
