Re: EPA Inspection of the City of Benton Harbor public water system (PWS ID# MI0000600) in Berrien County, Michigan

Region 5 Enforcement and Compliance Assurance Division
SDWA DRINKING WATER INSPECTION REPORT

City of Benton Harbor
Berrien County, Michigan

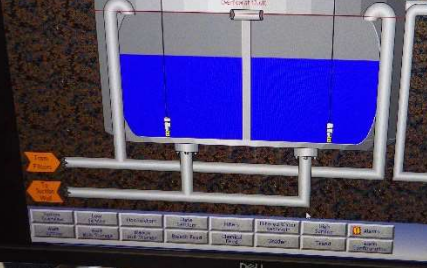
Photo 8	
File Name: RIMG0500	
Location: Benton Harbor PWS	
02/14/2022 08:36 AM (ET)	
Photographer: Sasha Letuchy	
Camera: RICOH WG-4 GPS	
Direction of Photo: Inside	
Description: Filtered water reservoir display through SCADA.

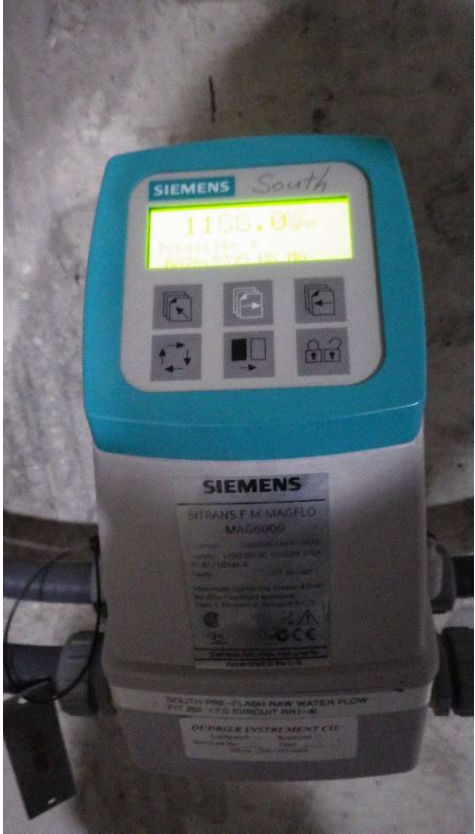
The team walked to the intake of raw water into the North and South Plate Settlers. On the North Plate Settler was the flow meter measuring the raw water flow entering the plate settler (See Photo 16). On the South Plate Settler was the flow meter measuring the raw water flow entering the plate settler (See Photos 17 and 18). Both raw water flow meters were online and connected to SCADA.

<p>Photo 17</p> <p>File Name: RIMG0509</p> <p>Location: Benton Harbor PWS</p> <p>02/14/2022 09:06 AM (ET)</p> <p>Photographer: Sasha Letuchy</p> <p>Camera: RICOH WG-4 GPS</p> <p>Direction of Photo: Inside</p> <p>Description: Raw water flow meter for the South Plate Settler.</p>

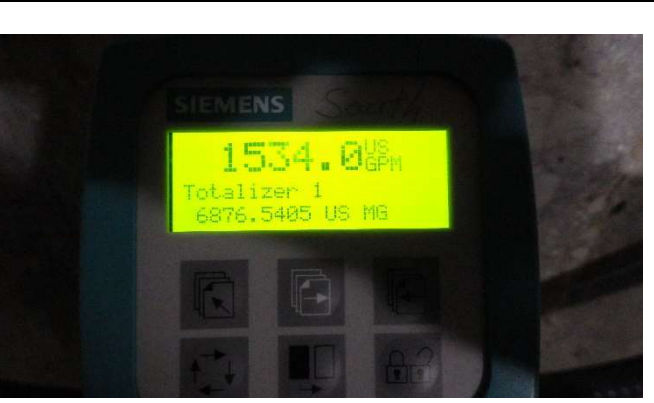
<p>Photo 18</p> <p>File Name: RIMG0510</p> <p>Location: Benton Harbor PWS</p> <p>02/14/2022 09:07 AM (ET)</p> <p>Photographer: Sasha Letuchy</p> <p>Camera: RICOH WG-4 GPS</p> <p>Direction of Photo: Inside</p> <p>Description: Repeat image of Photo 17. Raw water flow meter for the South Plate Settler.</p>

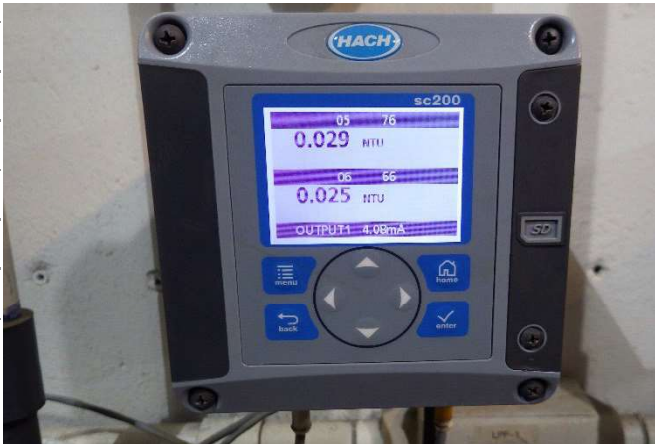
Photo 23

File Name: RIMG0515	
Location: Benton Harbor PWS	
02/14/2022 09:37 AM (ET)	
Photographer: Sasha Letuchy	
Camera: RICOH WG-4 GPS	
Direction of Photo: Inside	
Description: Filters 5 and 6 turbidimeter	
Photo 24

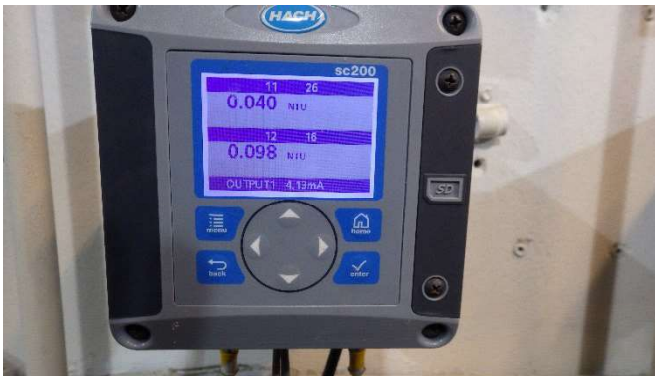
File Name: RIMG0516	
Location: Benton Harbor PWS	
02/14/2022 09:37 AM (ET)	
Photographer: Sasha Letuchy	
Camera: RICOH WG-4 GPS	
Direction of Photo: Inside	
Description: Filters 11 and 12 turbidimeter.

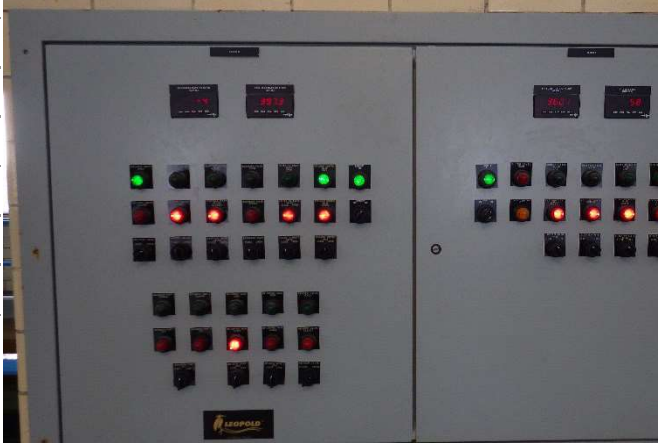
Photo 29

Description: PLC for filters 7 and 8.	
Photo 30	
File Name: RIMG0522	
Location: Benton Harbor PWS	
02/14/2022 09:44 AM (ET)	
Photographer: Sasha Letuchy	
Camera: RICOH WG-4 GPS	
Direction of Photo: Inside	
Description: PLC for filters 11 and 12.

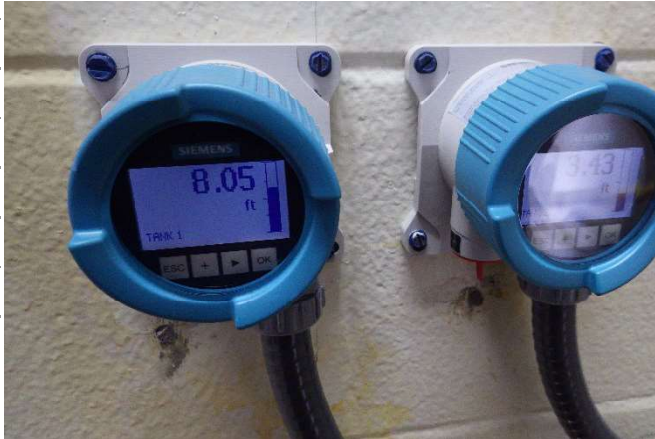
Photo 37

Following the onsite lab, the team walked to the bulk storage tank building which is in a separate building and located outside the main treatment plant facility. This building has two rooms and the first contains the three bulk chlorine storage tanks. The three bulk chlorine storage tanks are each equipped with depth sensors that continuously monitor the levels inside the tanks (See Photo 36). The chlorine tank depth sensors were online and connected to SCADA (See Photo 25). The second room of the building contained three bulk alum storage tanks and one bulk fluoride storage tank. The three bulk alum storage tanks each equipped with depth sensors that continuously monitor the levels inside the tanks (See Photos 37 and 38). The fluoride storage tank is no longer in service nor utilized by the system.

File Name: RIMG0529	
Location: Benton Harbor PWS	
02/14/2022 10:09 AM (ET)	
Photographer: Sasha Letuchy	
Camera: RICOH WG-4 GPS	
Direction of Photo: Inside	
Description: Depth sensor for Alum bulk tanks 1 and 2.	
Photo 38

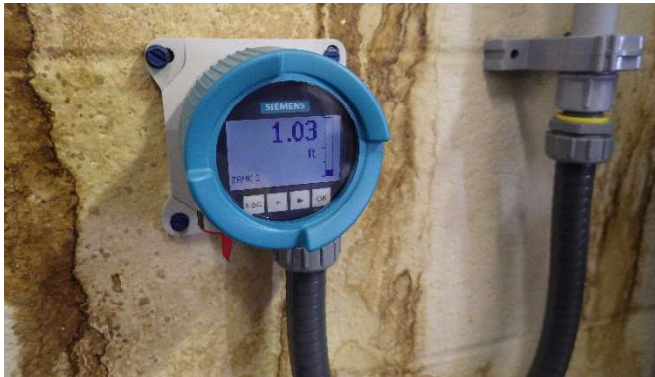
File Name: RIMG0530	
Location: Benton Harbor PWS	
02/14/2022 10:10 AM (ET)	
Photographer: Sasha Letuchy	
Camera: RICOH WG-4 GPS	
Direction of Photo: Inside	
Description: Depth sensor for Alum bulk tank 3.

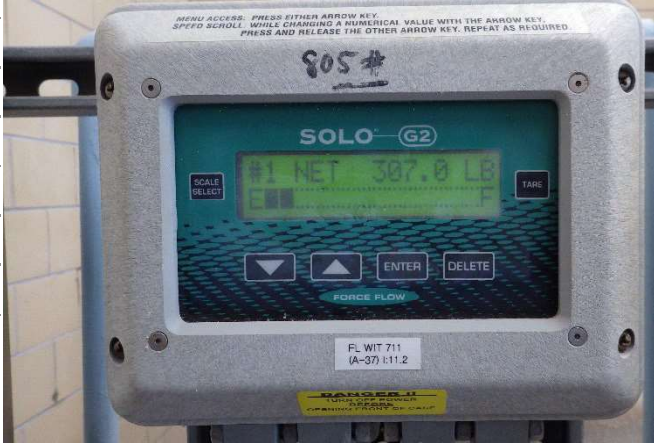
Following the bulk storage tank building, the team walked to the day tank storage area inside the main treatment plant. Inside the area, a meter reads the number of gallons used for the fluoride saturator (See Photo 40). The number of gallons used is included in a calculation to determine the net weight for fluoride dosage. The weight for the fluoride day tank was located in the storage area and was online and connected to SCADA (See Photo 41). Two chlorine day tanks were located in the storage area: one pre-chlorine and one post-chlorine. Both day tanks had devices that measured the weight of chlorine in each tank (See Photos 42 and 43). Both chlorine day tank devices were online and connected to SCADA.

<p>Photo 42</p> <p>File Name: RIMG0534</p> <p>Location: Benton Harbor PWS</p> <p>02/14/2022 10:33 AM (ET)</p> <p>Photographer: Sasha Letuchy</p> <p>Camera: RICOH WG-4 GPS</p> <p>Direction of Photo: Inside</p> <p>Description: Pre-chlorine day tank scales and weights.</p>

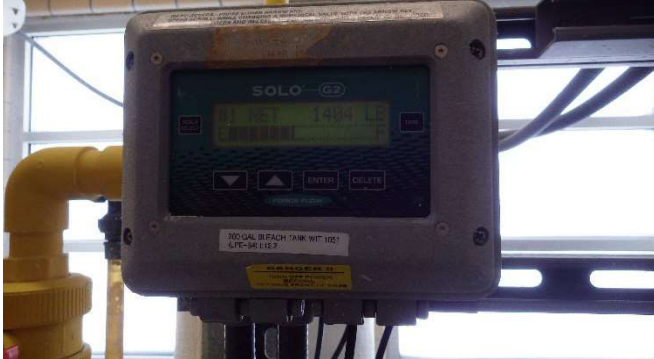
<p>Photo 43</p> <p>File Name: RIMG0535</p> <p>Location: Benton Harbor PWS</p> <p>02/14/2022 10:33 AM (ET)</p> <p>Photographer: Sasha Letuchy</p> <p>Camera: RICOH WG-4 GPS</p> <p>Direction of Photo: Inside</p> <p>Description: Post-chlorine day tank scales and weight.</p>
